Cracked Wheel Cylinder Turret

Cracked wheel cylinder turret – following installation

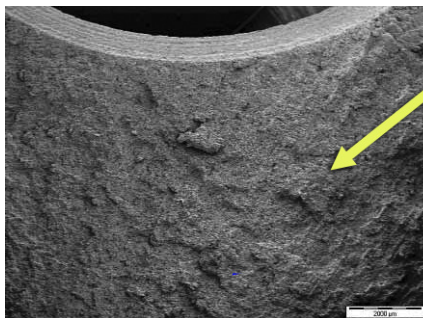
From time to time we receive wheel cylinders returned under warranty with cracked cylinder turrets. Following laboratory examination it has been confirmed that in all cases this is due to over-tightening of the hydraulic pipe nut/hose. A simple visual examination of the cylinder port can also provide evidence of over-tightening. The illustration below shows clearly a circular witness mark in the base of the port confirming an excessive torque load has been applied.

Laboratory examination confirms no fault in the casting

IMPORTANT: Always use the correct torque figure, specified by the vehicle manufacturer, when tightening hydraulic pipe nuts/hoses and bleedscrews.

Recommendation: Always fit hydraulic pipe nuts/hoses and bleedscrews by hand and finger tighten initially to prevent cross threading and subsequent damage to the cylinder. Use a suitable Torque wrench to tighten to the specified level.

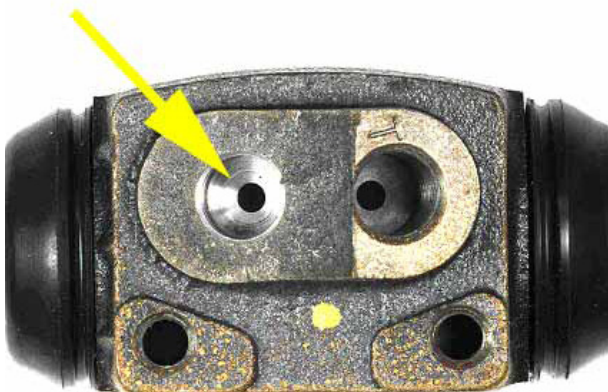
Circular witness mark
