INA Service Info

Pulse sensor 544 0095 10

Damage during removal

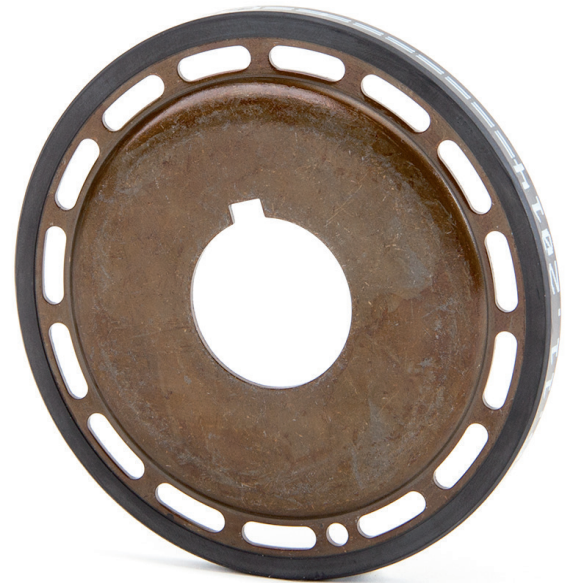
Fig. 1: 544 0095 10 – Pulse sensor for engine management

For the vehicles mentioned above, the crankshaft vibration damper with pulse generator must always be removed in order to work on the timing drive. The pulse generator may be damaged during the removal process.

The material combination often makes it very difficult to release the pulse generator for engine management (Fig. 1) from the crankshaft vibration damper (Fig. 2) once these components have been removed.

In most cases, the pulse generator will also be damaged at this point. It is therefore advisable to always replace the pulse generator.
