# febiEXAKT

## Shaft seal with ABS impulse ring

**febi no. 38868**

**Mercedes Benz W204, W207 and W172**

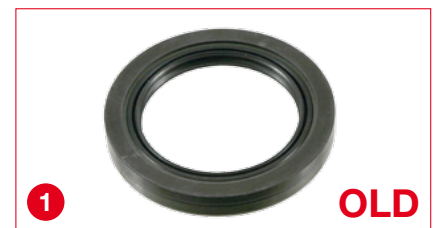
The original version (Repl. no. 203 330 0060) of the shaft oil seal has no rotating collar (Fig. 1). The stub axle surface becomes corroded and worn, resulting in the running surface of the shaft seal to become uneven and eventually causing failure of the shaft seal.
