# Electrical EGR-valve (Opel/Vauxhall)

## Adhesions/coke deposits on the valves

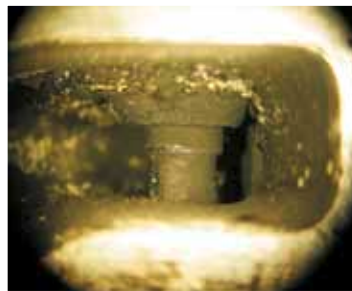
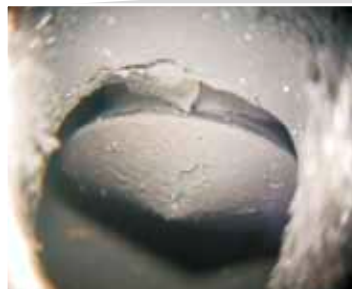
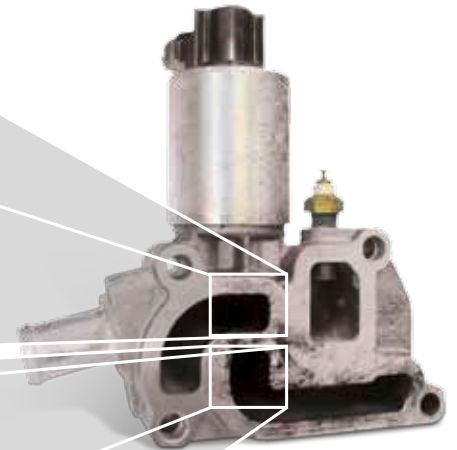
“Faulty EGR-valve” is the diagnosis determined on inspection in the workshop. The built-in electrical EGR-valves are adhering or are coked with oily deposits on the valve plate or seat.

- The opening cross-section of the EGR-valve is reduced.
- The valve does not open or close fully.

The causes of these coke deposits are not to be found in the EGR-valve.

The most frequent causes of faults in the case of the EGR-valves mentioned here are deposits on the valve plate or the valve seat. The EGR-valve must be inspected and changed if necessary.

In many cases updating the control-unit software can solve the problems of excessive coke deposits.

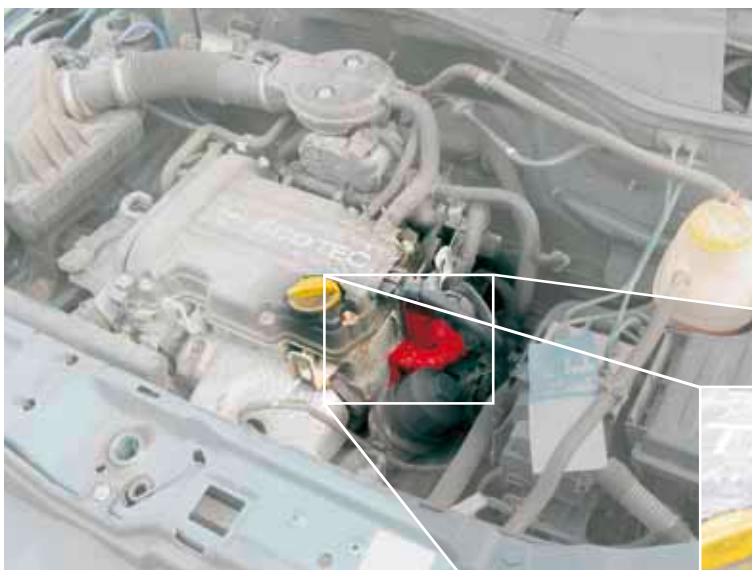
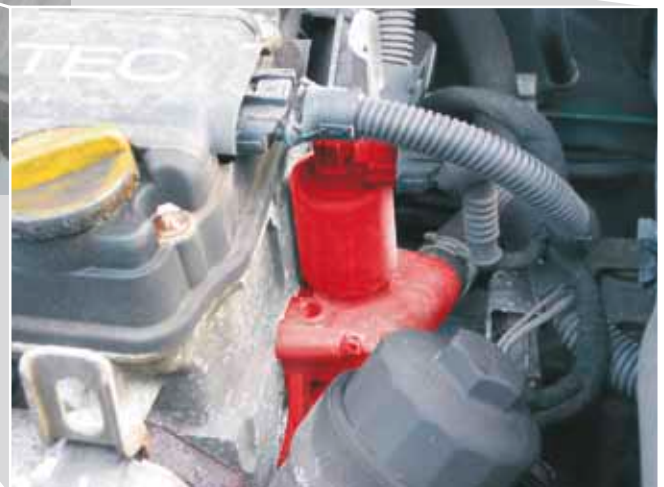
*Electrical EGR-valve in the Opel Corsa (highlighted)*
