# In response to complaints relating to turbochargers ...

## ... always also check the surroundings

Vehicle	Product	PIERBURG No.
Various, turbocharged	Electropneumatic pressure converters (EPW) Electric switchover valves (EUV) Vacuum pumps	see catalogue/TecDoc CD

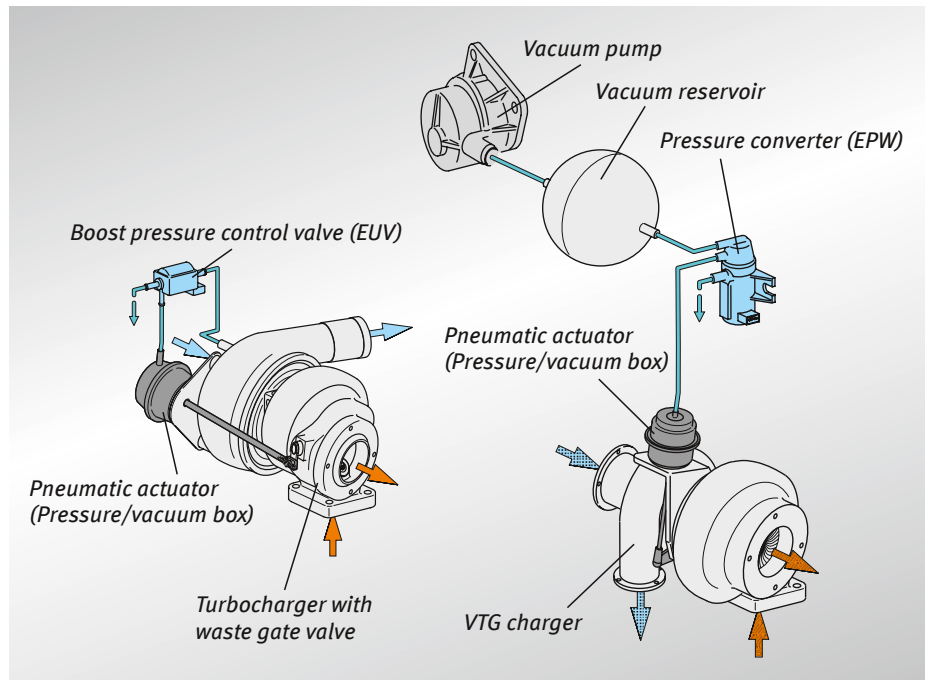
- defective electropneumatic valves
- a vacuum pump delivering an insufficient vacuum
- leakage in the vacuum system

In the case of complaints which point to the turbocharger being at fault, always the components around it must also be checked.

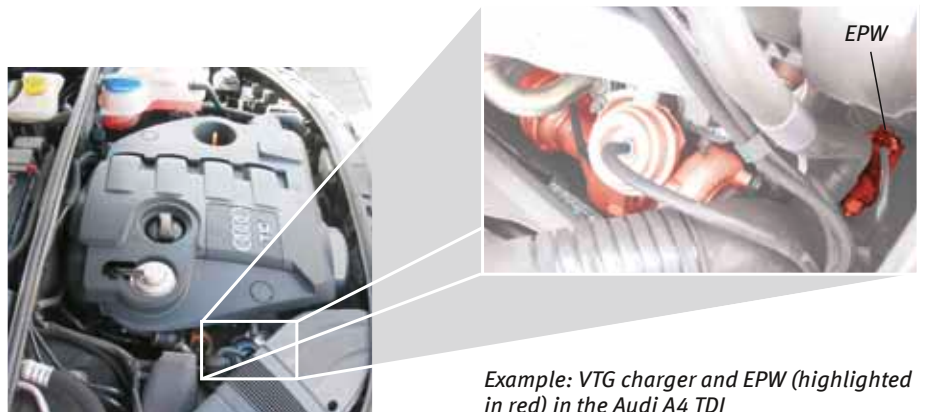
Example: VTG charger and EPW (highlighted in red) in the Audi A4 TDI
