SKF Technical Bulletin

VKJC 1045/1046/5205/5208 – Mandatory Stub-shaft kit replacement combined with driveshaft kit

VW Multivan V, Transporter V

Mandatory Stub-shaft kit replacement combined with driveshaft kit

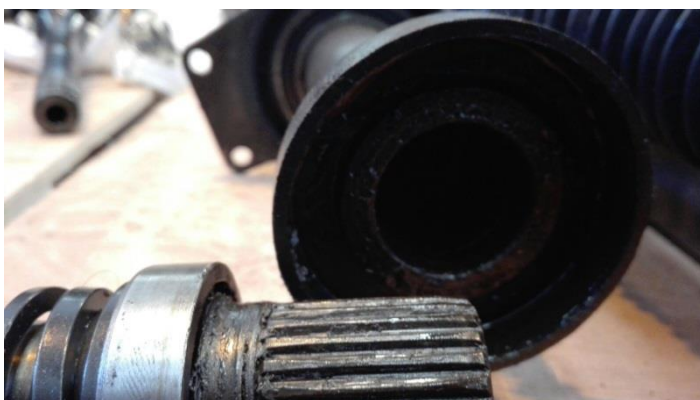
Pic. 1

Due to vehicle transmission dysfunctions on the above applications, there are issues with the original gearbox side toothing the driveshaft which leads to premature stub-shaft and driveshaft failure, as shown below on Pic 1 and Pic. 2.

The problem will persist if the driveshaft is replaced without a new stub shaft. Indeed, the toothing of the original stub shaft will present more tolerance than required, so it will prematurely damage the driveshaft toothing.

Therefore, for a complete and professional repair, SKF is offering both components and strongly recommends replacing the driveshaft and the stub-shaft kits at the same time:
