Installation tip for tensioning pulley CT1114K1 and CT1115K1 for various Fiat, Ford, Lancia, Alfa 1.1-1.4 engines

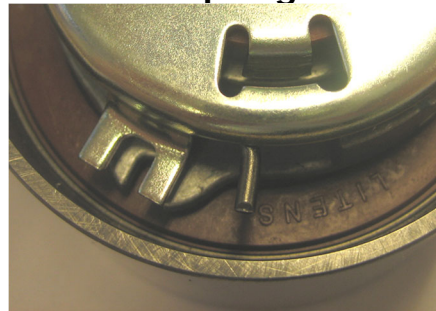
During installation, the spring is seen to be detached from the pulley, which means that it is no longer possible to set the tension.

Inexpert handling of the pulley during setup (no use of special tool OE 1860987000) can cause the end of the spring to jump out of the recess as a result of the spring recoiling.

Fig. 1
Detached spring

In these cases the spring can be repositioned by means of manual pretensioning using a suitable tool (long-nosed pliers or similar) and attached. For correct installation using tensioning pulley OE 1860987000 tension the belt by rotating the pulley clockwise.

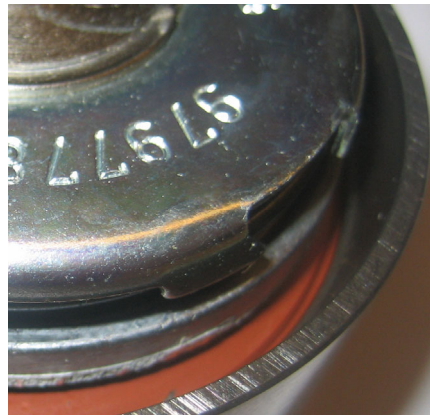
Fig. 2
Recess

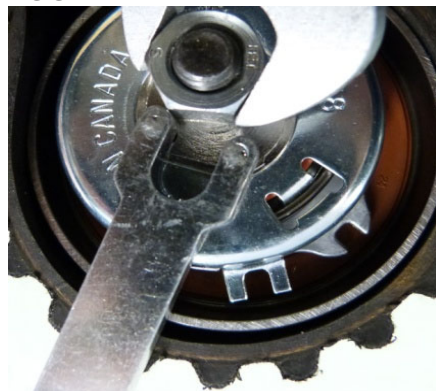
Fig. 3
Tool
