# Technical *Info*

## Mounting Instructions for the CT 1044 K1 Timing Belt Kit For example, Audi/VW/Skoda/Seat 1.9 TDI

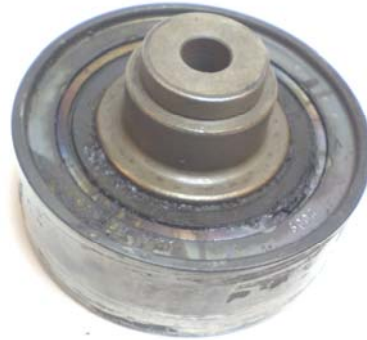
Fig. 1

The large idler pulley breaks away following a short period of operation due to bearing blockage. This can lead to engine damage (Fig. 1).

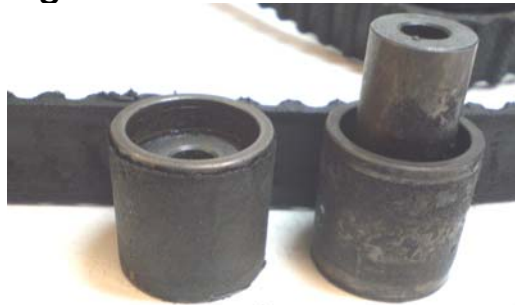
Fig. 2

Owing to insufficient tension, the back of the timing belt becomes heated up on the two stabilizing rollers (fig. 2).
