Technical *data*

Installation of the tension pulley from CT 604K1, CT 684K1, CT 711K1, CT 840 K1/K2, CT 935 K1/K2, CT 940 K1/K2, CT 949 K1 for diverse Renaults

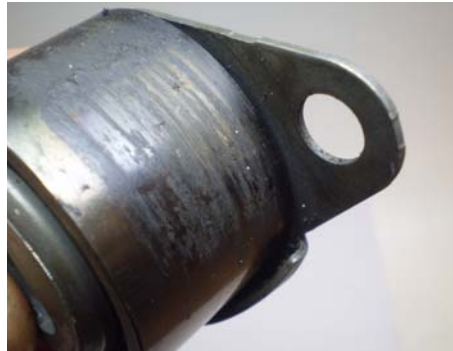
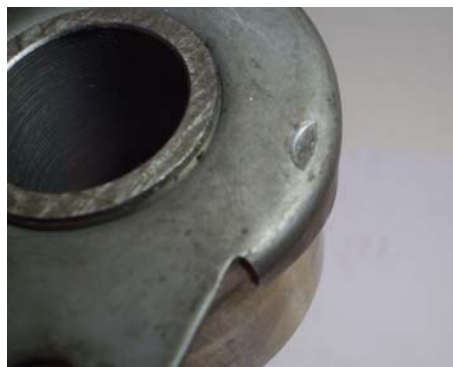
The tension pulley gets locked after a short period of operation. The back of the belt becomes overheated and the idler pulley suffers thermal damage.

During tension pulley installation, attention was not paid to ensure that the pulley revolves around its axis properly and/or the nut is tightened sufficiently. This caused the pulley to twist under load and the jacket was blocked on the inside by a bent retaining plate.

1. Care must always be taken to ensure that the tension pulley is correctly installed on the mounting surface (lug must be properly seated in the recess of the retaining plate).
2. In addition, the specified tightening torque of 50 Nm must be observed during installation.
