Control arm bushing to fit Audi, Seat, Skoda, VW

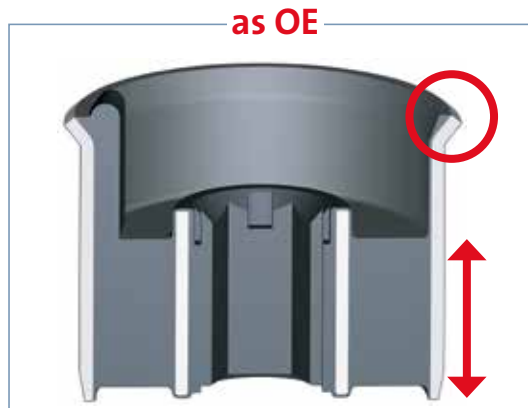
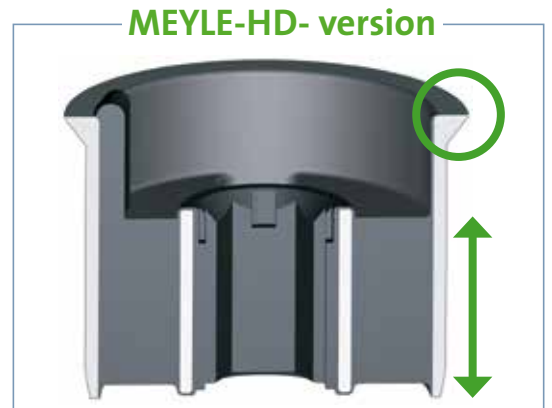
Rubber bearing does not provide enough cornering force and can wear out

Steering play, accurate lateral guidance no longer possible

Reinforcement of the critical rubber dimensions for enhanced bonding of the inner control arm mount to the outer sleeve
