NEW PRODUCT HIGHLIGHT | OCT 2019

SWAG 30 10 9623

HARNESS FOR ENGINE

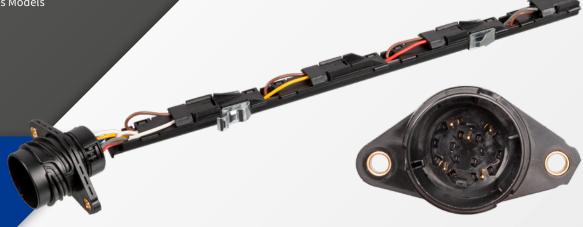
Unit injector wiring loom harness which is positioned in the cylinder head. This attaches to the engine wiring loom which is connected to the engine control unit, and controls the diesel injector solenoids.

Engine misfiring or not starting, due to a poor or broken connection of the wiring harness to the injectors, also deterioration of the wiring insulation causing a short or open circuit. SWAG recommends when replacing the diesel injectors that the wiring harness is also replaced in order to reduce the risk of any connection problems. It is also recommended that the rocker cover gasket is replaced at the same time, as they often leak once disturbed.
