ZF Aftermarket Service Information

Suspension spring broken

Document number

40921 EN

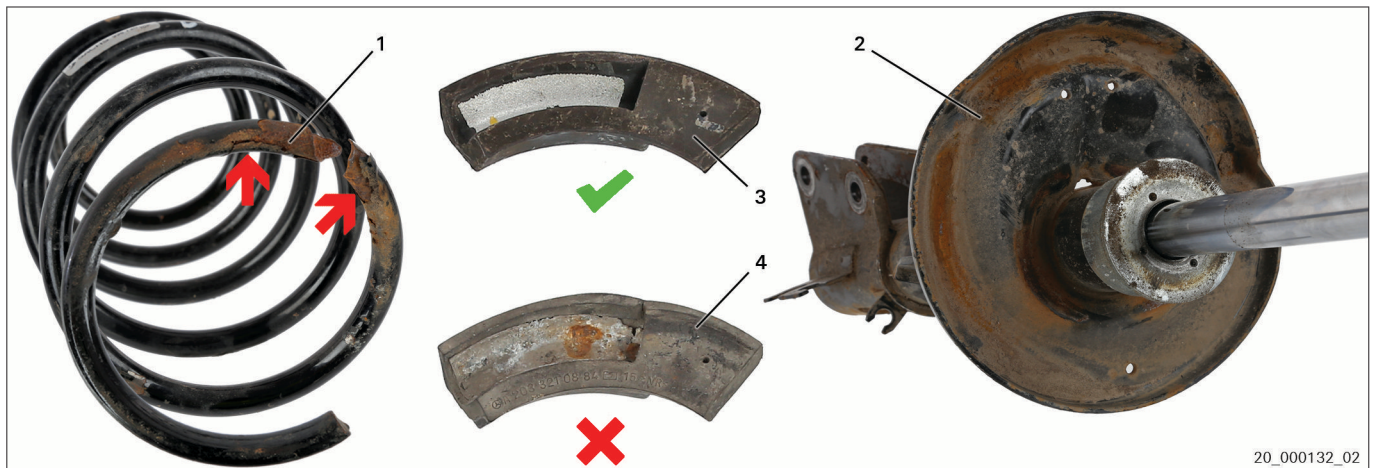
Fig. 1 Suspension spring, spring seat and spring support

- 1 Suspension spring (broken)
- 3 Spring support (new)

- 2 Spring seat with dirt and corrosion
- 4 Spring support (worn)

i Dirt and rust scars in the spring seat (2) are like abrasive paper. The protective coating of the suspension spring (1) wears prematurely. Water and dirt might penetrate through cracks and cause corrosion on the suspension spring (1).

Possible cause	Action
Corrosion protection coating of suspension spring (1) damaged.	Clean vehicle-end contact points of suspension spring (1), check for condition and wear. Replace damaged parts: spring seat (2) / spring support (3) / sacrificial anode / ...
