Quick inspection of secondary air valves

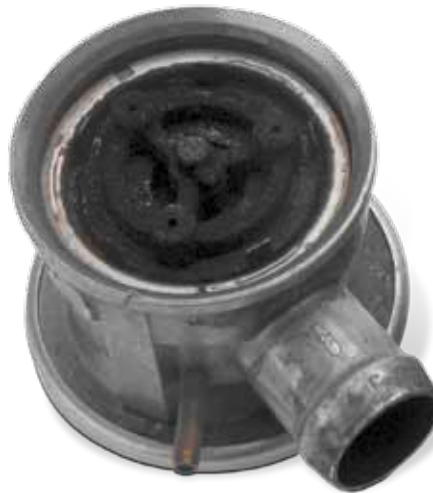
Damage as a result of exhaust gas condensate

In almost all cases this damage is caused by exhaust gas condensate in the secondary air pump.

When replacing the secondary air pump, the electrical reversing valve and the secondary air valve must be inspected for leaks as a basic principle.

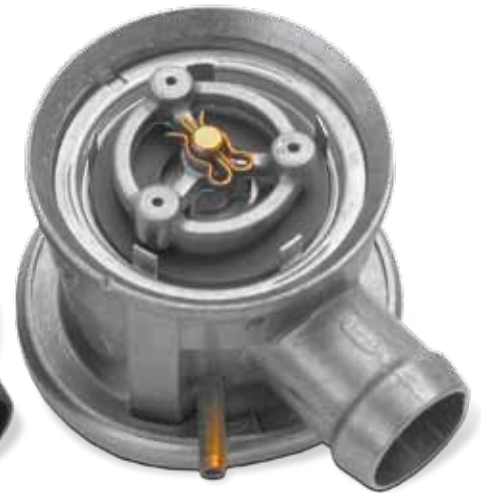
The new condition as a comparison

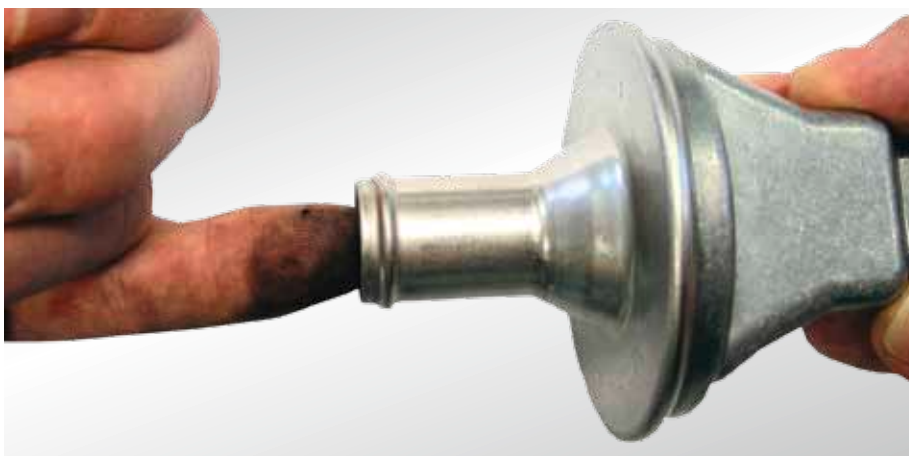
- Loosen the connecting hose on the secondary air non-return valve leading to the secondary air pump. See inspection point "P" on the graphic overleaf
- If there are deposits on this side of the valve (finger test, see adjacent Figure), the nonreturn valve is leaky and must be replaced. In that case the secondary air pump may already have been damaged.
- Inspect the secondary air pump and replace it if necessary.

Simple inspection of the non-return valve

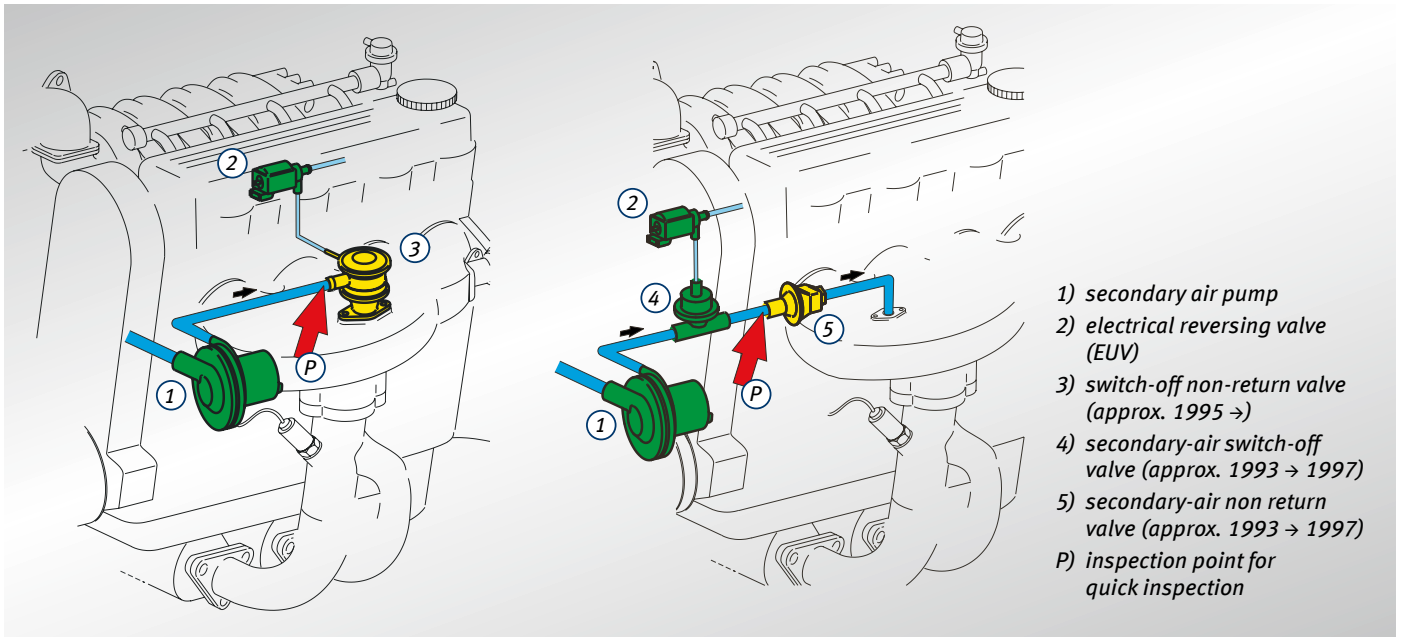
Two variants of the secondary air system

Secondary air valves are an integral part of the secondary air system. They are fitted between the secondary air pump (1) and exhaust manifold.

Switch-off non-return valves (3) are generally vacuum-operated valves. Later designs (from approx. 1998 to date) are opened by the pressure of the secondary air. This does away with pneumatic control by an electrical reversing valve (2). Secondary-air non-return valves (5) open as a result of the pressure of the secondary airflow.

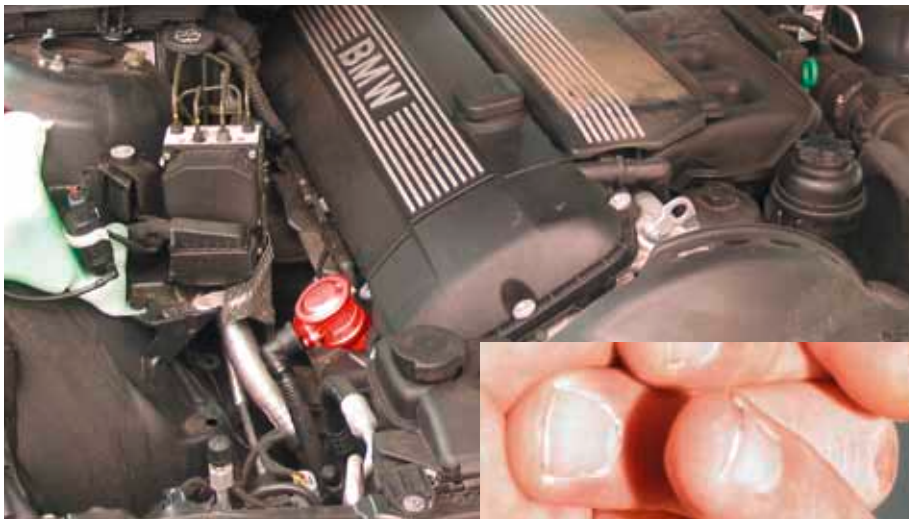
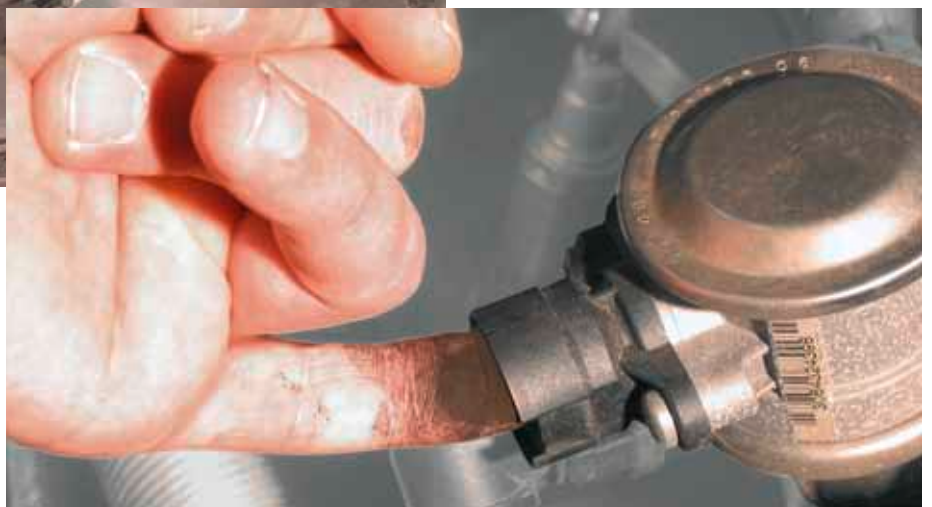
Quick inspection of the secondary air valve in the BMW 520i (highlighted)
