## Cost-effective repair solution for leaks in the gearbox!

In various Renault models with manual gearbox (Type JB and JC), oil may escape through the leaking shaft seal ring (oil seal) of the gearshift lever.

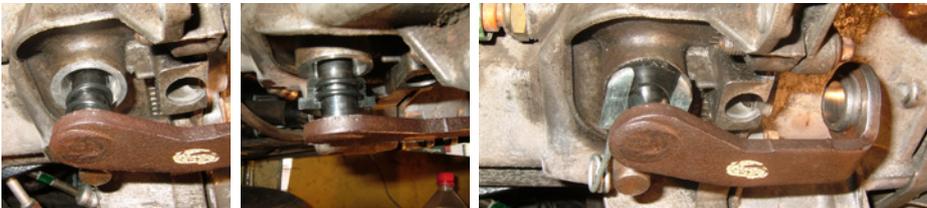
The repair kit febi 47222 offers the option of sealing the shaft using two half shells and two o-rings. This saves the customer money because it significantly reduces the time needed for the repair.

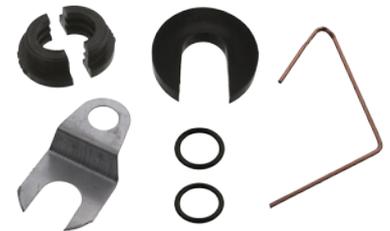
febi no. 47222

The repair kit comprises:

- Two rubber rings
- A wire which is used to pull the rubber rings over the gear lever onto the shaft
- Two half shells
- A plastic plate which is used to drive the two half shells together with the inserted rubber rings into the opening
- A metal plate
