# febiEXAKT

## Shaft seal with ABS impulse ring

**febi no. 38868**

**Mercedes Benz W204, W207 and W172**

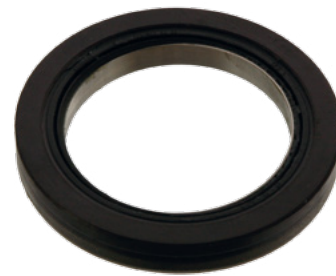
Damage or corrosion to the running surface of the stub axle may cause damage to the shaft seal. The result of this is a premature failure of the wheel bearing.

The original version (Repl. no. 203 330 0060) of the shaft oil seal has no rotating collar (Fig. 1). The stub axle surface becomes corroded and worn, resulting in the running surface of the shaft seal to become uneven and eventually causing failure of the shaft seal.

The manufacturer has provided the shaft seal with a rotating collar (see arrow, Fig. 2). The stub axle and the front wheel hub are not affected by this change. febi bilstein recommends replacing the shaft seal with the most up-to-date version (Fig. 2). Due to optimisation of the shaft seal, it is no longer necessary to replace the stub axle if the running surface is damaged slightly, the rotating collar serves as a substitute for the stub axle's running surface.
