Control arm bushing to fit Audi, Seat, Skoda, VW

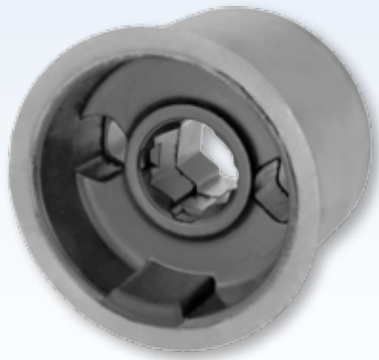
Rubber bearing does not provide enough cornering force and can wear out

Steering play, accurate lateral guidance no longer possible

Reinforcement of the critical rubber dimensions for enhanced bonding of the inner control arm mount to the outer sleeve
