Montageskizze - Mounting diagram

Anschlussdiagramm – Wiring Diagram

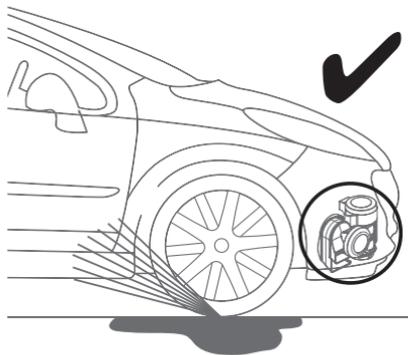
Sachgemäßer Einbau Correct installation

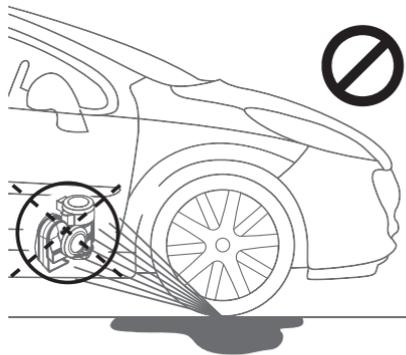
Unsachgemäßer Einbau Improper installation

The warranty by Robert Bosch GmbH or any subsidiaries is not applicable for damages caused by improper installation.
For correct installation please contact a specialists workshop.

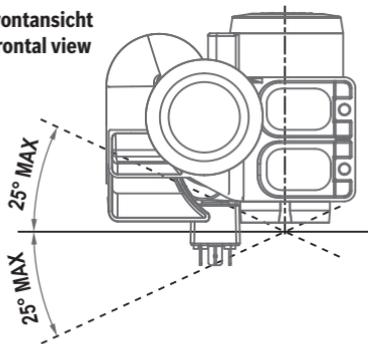
Frontansicht
Frontal view

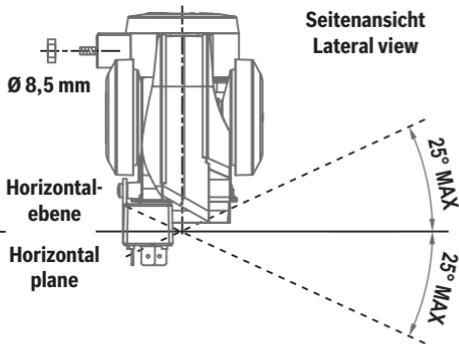
Seitenansicht
Lateral view

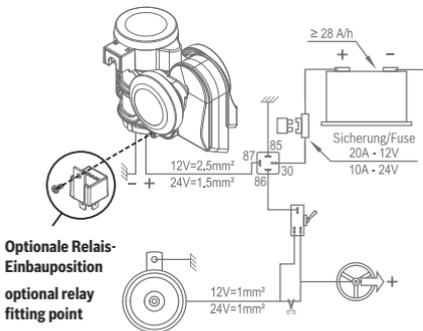
Montage des Airmasters als zusätzliche Hupe – Horn mounted in addition to normal horn

Anschlussdiagramm mit positivem Pol am Schalter Hupe
– Wiring diagram with positive terminal to horn button

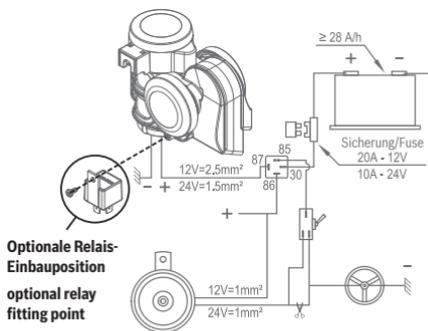
Anschlussdiagramm mit an der Fahrzeugkarosserie geerdetem Pol am Schalter Hupe – Wiring diagram with ground lead to horn button

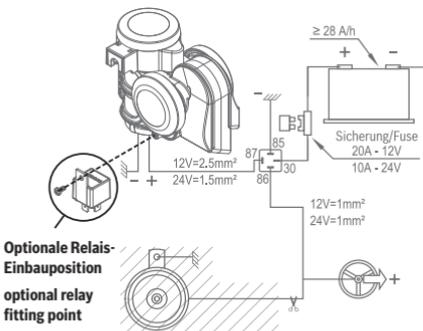
Montage des Airmasters als Ersatz der bisherigen Hupe – Horn mounted instead of normal horn

Anschlussdiagramm mit positivem Pol am Schalter Hupe
– Wiring diagram with positive terminal to horn button

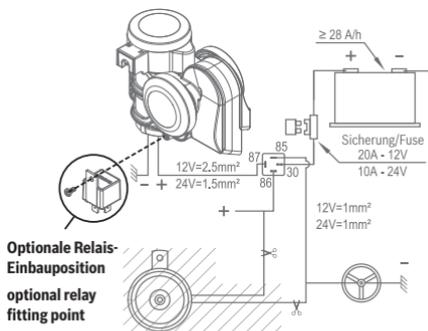
Anschlussdiagramm mit an der Fahrzeugkarosserie geerdetem Pol am Schalter Hupe – Wiring diagram with ground lead to horn button
