Technical Report #55

Cylinder head bolts: design changes on head & washer

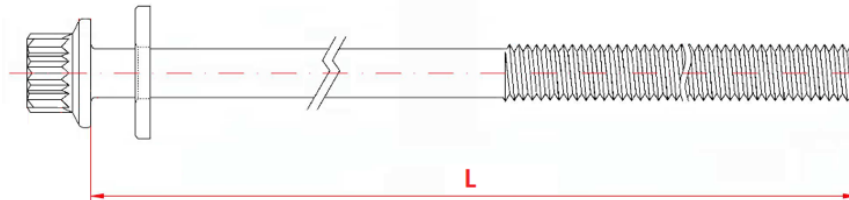
In some part numbers, the original manufacturer **changes the original design of the bolt**, which turns **from having a loose washer to include it in the head as a flange**. When the flange is included, the length of the bolt stem decreases (measured from under the head to the threaded end), because the thickness of the washer is included.

Bolts set	Head change Previous → Current	L (mm) Previous		L (mm) Current
81002000		178,5		173
81007100		103		99
81007100		85		83,5
81010100		95		91
81010100		60		56
81016100		119	119	121
81017400		146		142
81022300		106		103
81024700		131,5	131	126
81029300		144		140
81033400 & 81037800		225		219
81044800 & 81045000		204		200

In these cases, Ajusa also adapts its bolts to the new design, being the part numbers involved the following:

Therefore, it is possible that, when dismantling the original bolts in order to replace the cylinder head gasket, we find a bolt with washer instead of the current bolt with flange. In these cases, the current bolt can be perfectly mounted.
