## Danger of incorrect application of tensioning pulleys 531 0054 30 and 531 0626 30

Opel, Vauxhall, Holden

**LuK AS Part No.:** 531 0054 30  
531 0626 30

Issued 11.2007  
**INA 0005**

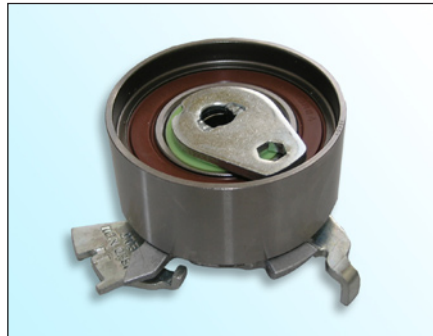
**Fig. 1:** 531 0626 30 (979488)

Both models appear to be identical from the outside.

The tensioning pulley **531 0626 30** has an extended tensioning range, as well as a higher-temperature bearing.

When installing the above-listed tensioning pulleys, **correct** vehicle application must be ensured.

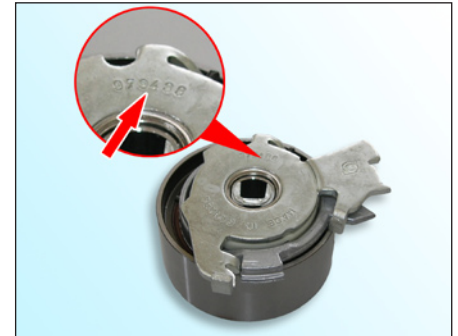
**Fig. 2:** 531 0626 30 (979488)

The tensioning pulleys can be distinguished by the manufacturer number stamped on the rear face (**fig. 2, arrow**).

The pre-tensioning force and the damping of the tensioning pulleys are different!

Incorrect assignment could cause the toothed belt to jump, resulting in damage to the engine.
