MEYLE No.
Ball joint: 016 010 0005/HD

Ball joint to fit

Smart

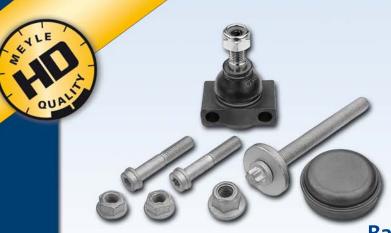
Premature wear due to extremely thin plastic socket and inadequate sheathing of the ball pin

Effect

- Noise from the front end
- Unstable handling
- Inadequate front suspension control

Use of a thicker plastic socket covering a much greater area of the ball

Advantage

A significantly more robust ball joint design results in longer life and less wear
